Manhole Inspection Summary

Manhole # S21E__062MH

Insp Date: **10/16/07 9:51 AM**

Location Address: **255 SARATOGA ST**

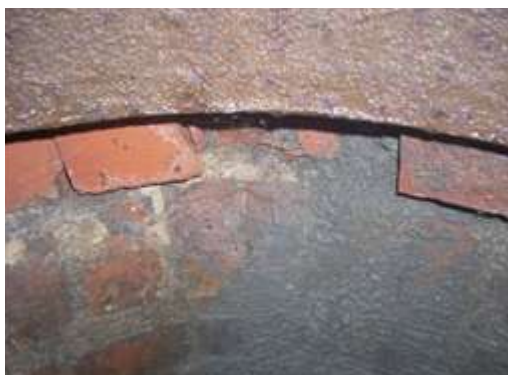
Defect 3

Condition: ☐ Sound ☐ Cracked ☐ Root Intrusion ☒ **Loose Brick** ☒ **Deteriorated**

DETERIORATED CHIMNEY WITH
LOOSE BRICKS

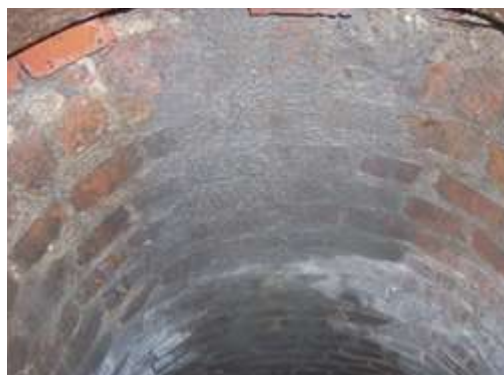
Defect 2

Infiltration: ☐ None ☒ **Joint** ☐ Cracks ☐ Mortar ☐ Roots ☐ Wall

INFILTRATION OF THE CHIMNEY
JOINT

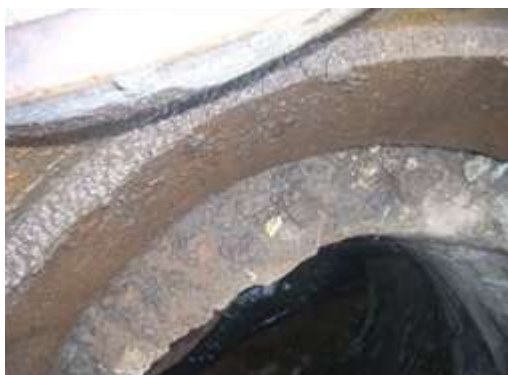
Defect 1

Frame Offset: **3** (in.) Condition: ☒ Sound ☐ Cracked ☐ Leaks

FRAME OFFSET

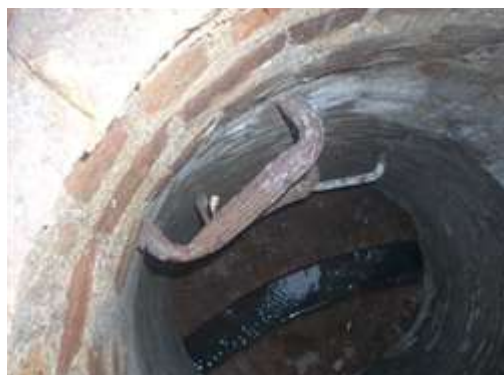
Defect 4

Steps Count: **4** Missing: **0** ☒ **Corroded**

CORRODED STEPS

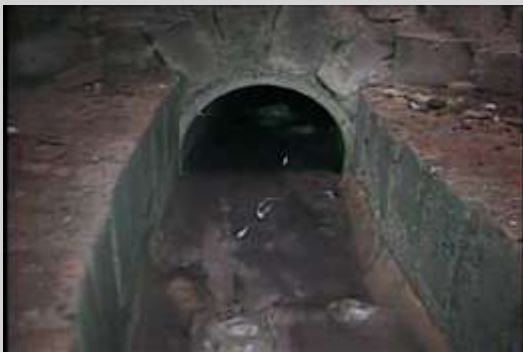
12 O'Clock Outflow

8 in. Circular Gravity Sewer
Pipe Out @ 12 O'Clock

Pipe Height: **8.4** (in.) Rod and Bar (Angled)
Pipe Material: **Clay** ☐ Pipe Lined
Invert Depth: **9.36** (ft.) Flow Characteristics: **Slow**
Deposits: ☒ None ☐ Mud ☐ Sludge ☐ Debris ☐ Grease
Silt Depth: (in.) Deposits Extent:
Infiltration: **None** Pipe Seal Cond: **Sound**

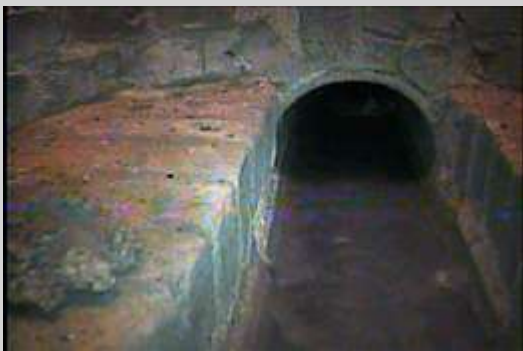
5 O'Clock Inflow

8 in. Circular Gravity Sewer
Pipe In @ 5 O'Clock

Pipe Height: **7.2** (in.) Rod and Bar (Angled)
Pipe Material: **Clay** ☐ Pipe Lined
Invert Depth: **9.24** (ft.) Flow Characteristics: **Slow**
Deposits: ☒ None ☐ Mud ☐ Sludge ☐ Debris ☐ Grease
Silt Depth: (in.) Deposits Extent:
Infiltration: **None** Pipe Seal Cond: **Sound**
